National Transportation Safety Board Marine Accident Brief

Fire and Explosions On Board Towing Vessel *Safety Runner* and Kirby Barges *28182* and *28194*

Accident no. DCA13NM019

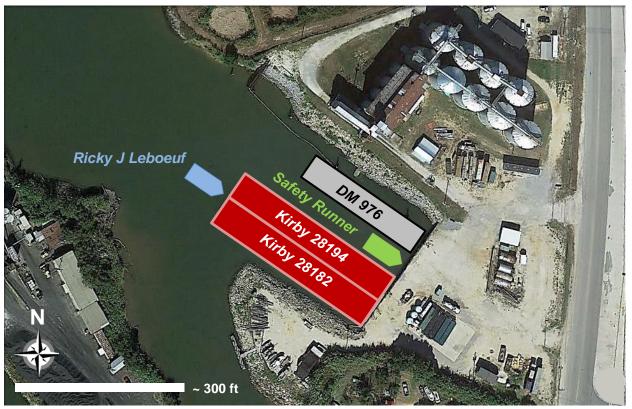
Aerial view of the ORC Facility. Overlaid in the image are icons representing the vessels and barges that were present at the time of the accident, and their approximate positions. (Background by Google Earth)
